VILLAGE OF GILBERTS

RESOLUTION 03-2021

A RESOLUTION AUTHORIZING APPROVAL OF AN AGREEMENT WITH MUNICIPAL WELL AND PUMP FOR REPAIR SERVICES AT WELL 4 IN AN AMOUNT NOT TO EXCEED \$150,000

Re: Gilberts Well #4

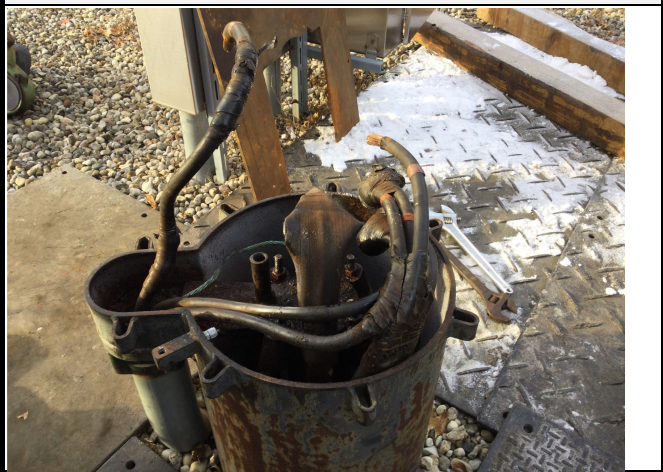
1. Splice

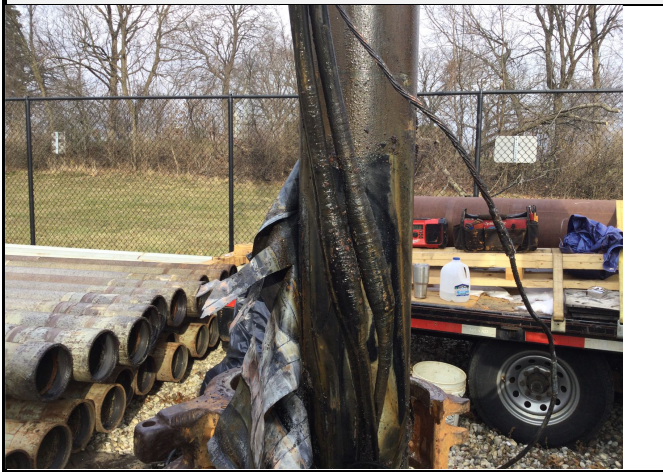
2. Splice intact

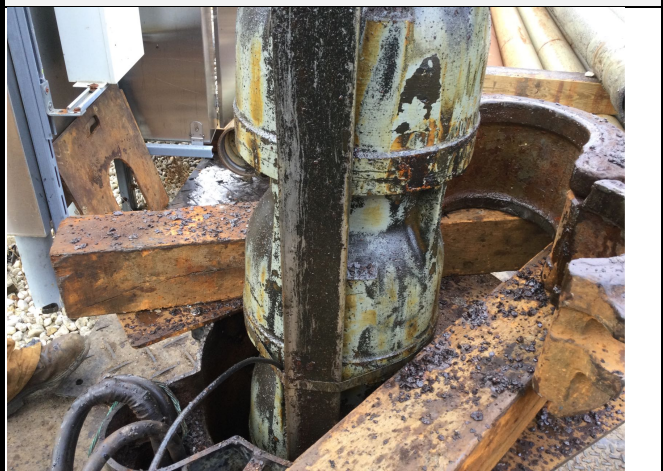
3. Cable guard intact

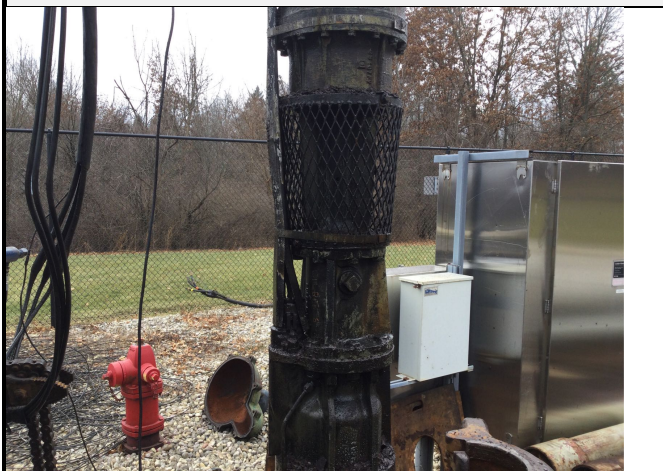
4. Cable guarded properly

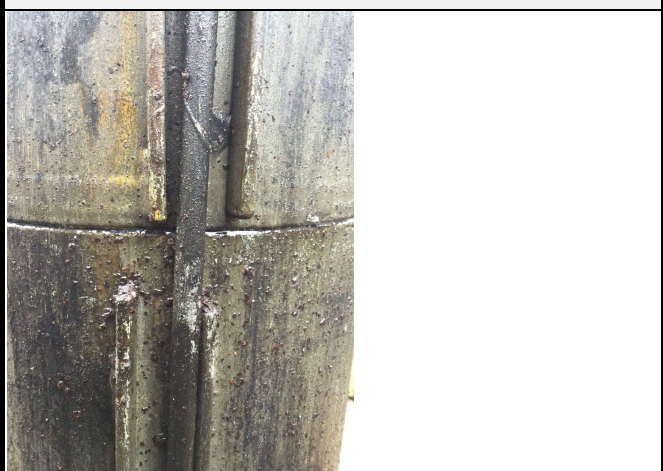
5. Oil can turned

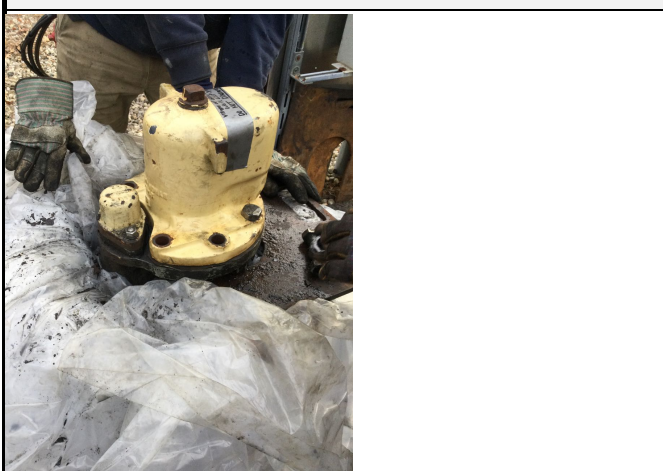
6. No mercury found

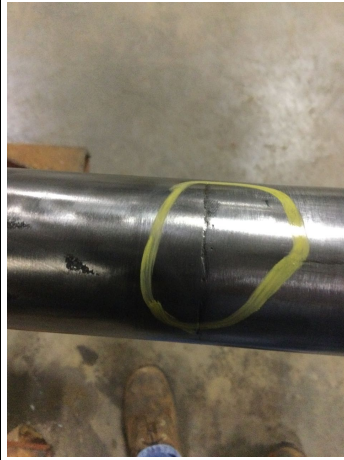
Shaft face to adapter face, 7 5/8". Sand collar face to shaft face 17 5/8". Shaft wore and undercut, deep pits. Bowl has Washing on inside, was rebuilt once before. Not rebuildable. Bowl has orings. Bowl vanes are wore and severe graphitization is occurring.

1. Pitting on shaft

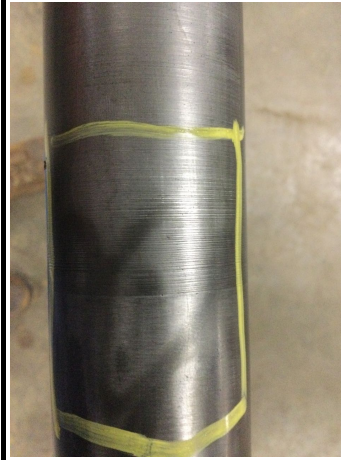
2. Wear on shaft

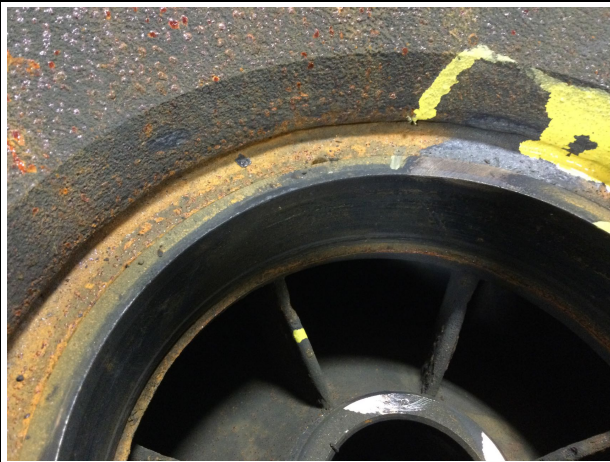
This unit has been rebuilt once before, but most importantly severe deterioration has started on the interior cast iron vanes and castings. Washing out of the cast iron in the wear ring area eliminates the feasibility of rebuilding the unit and a new bowl must be purchased. This deterioration is caused by "graphitization". Graphitization is a metallurgical term whereby the cast iron becomes soft. Cast iron, being made up mostly of iron and carbon, gets soft or graphitizes by the iron being leached out of the cast iron and you are basically left with carbon or graphite. When you scrape the cast iron, the carbon looks just like scraping pencil lead. The attached report shows the condition, with pictures.

3. Bowl washed at wear ring critical area

A new bowl assembly will require about 2 to 3 weeks to build and test. The bowl assembly we are proposing is a Gould's 12CMC-14 stage bowl with Sub-adapter, stainless steel screen bronze bearings, 416-stainless steel wear rings, 316stainless steel impellers, stainless steel shaft, bolting. We have the parts in stock, but we require machining of the wear rings and testing of the motor and bowl.

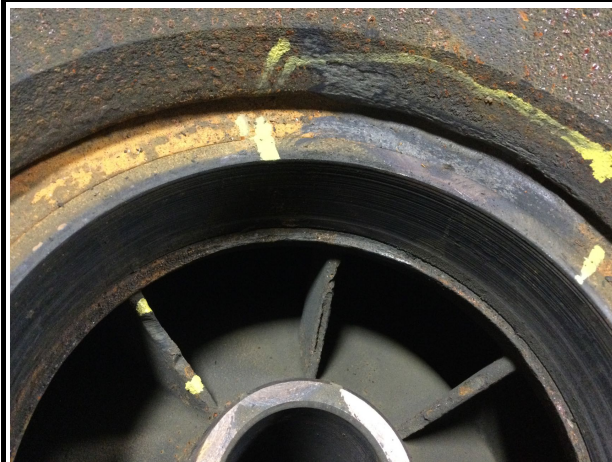
4. Vanes very poor and soft

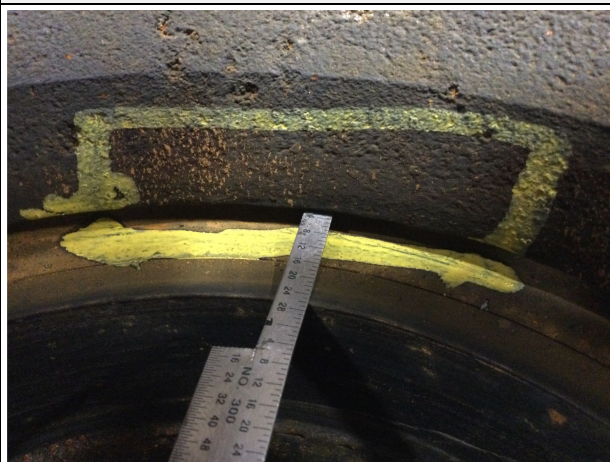
5. Undercut on suction case

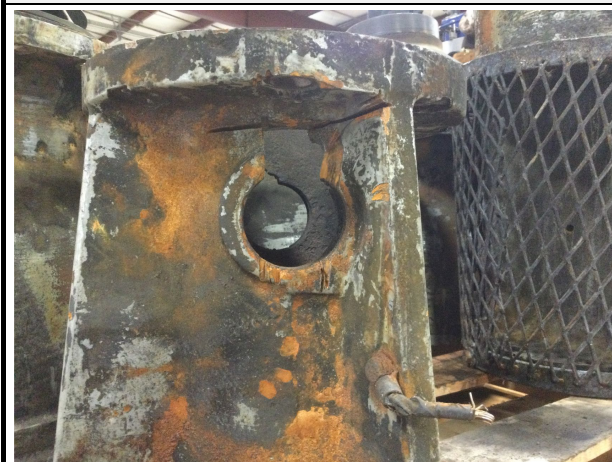
6. Cut adapter case due to motor seizure.

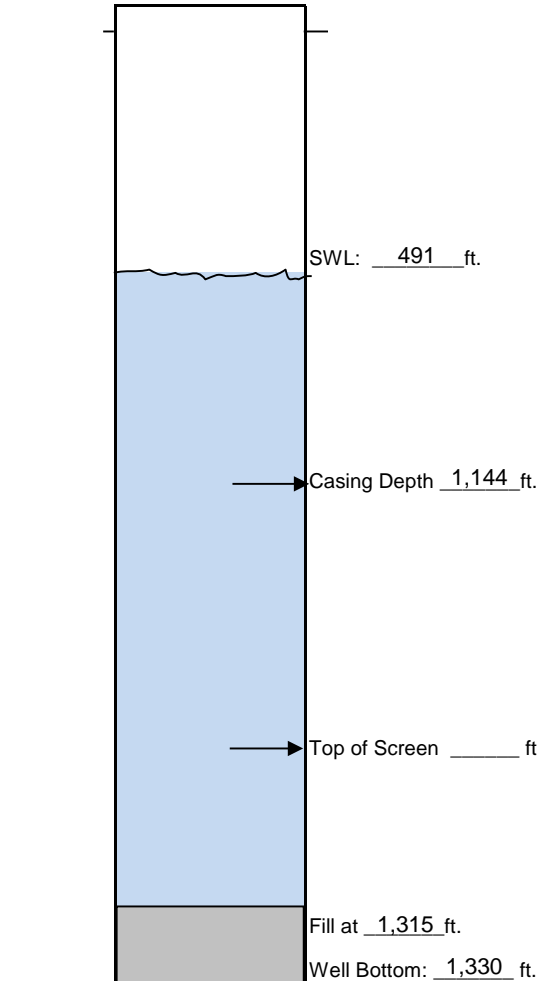
Well Diagram

Results
<p>Thick oil at static level. Well appears to be crooked in open hole. Oil particles in fill at the bottom of the well. Casing has much loose scale on it. Deposits are sitting on all ledges in the open hole.</p>

Recommendations
<p>Bail oil. Brush casing. Treat open hole. Bail fill.</p>
